DAM INSPECTION CHECKLIST POSSUM POINT POWER STATION POND ABC

INSPECTION DATE: 11/20/15 1153 hrs

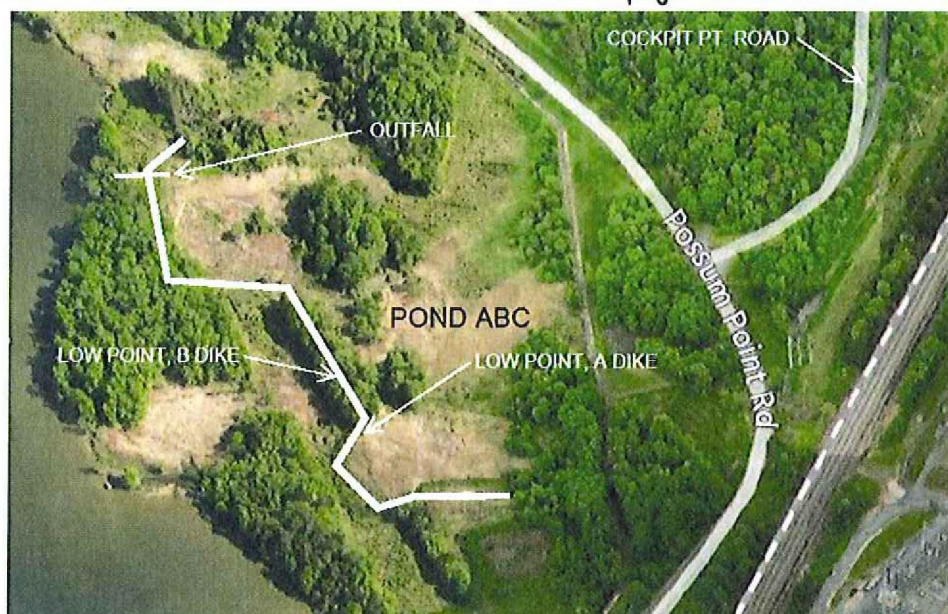
* See figure below.

Location/ Condition	(y/n)	Change (y/n)	Comments
Low Point, A dike*			
Flow	N	N	1153 hrs. Small amount of standing water behind sandbagged area. Sand bags and rip rap in place.
Erosion	N	N	Road wet from rain.
Low Point, B dike*			
Flow	N	N	1155 hrs. No standing water. Sand bags and rip rap
Erosion	N	N	in place. A couple minor tears in sandbags.
Outfall			
water surface El. (top of stoplogs to water)			1203 hrs. 64". No discharge. A few drops of water seeping into concrete weir structure at a rate of roughly 2 drips every 2 seconds.
